PROBLEM SOLVING: Water Marks

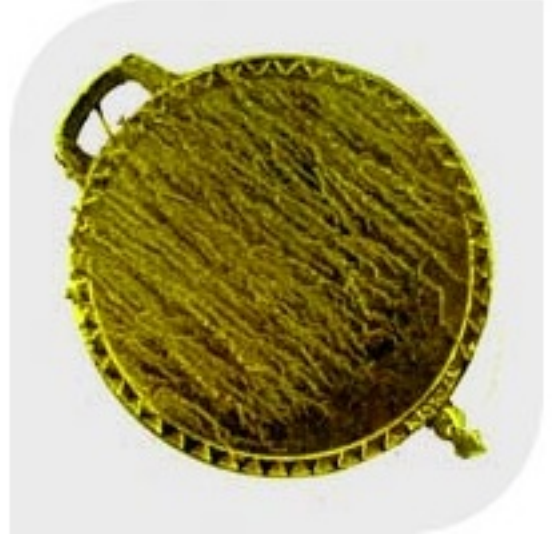
causes:

1. Not using all the work time
2. Too much water

Water marks are irregular traces on the surface of the casting which runs vertically from top to bottom (viewed from how the flask is filled with investment). Water marks are generally more pronounced on flat items.

Solution - See manufactures instructions. If the work time is not fully used then particle segregation will occur, leaving a water rich investment which will be attracted to the surface of the waxes. This results in erosion. As a general guide the time between final vacuum and the gloss off should be 2.5 to 3 minutes

Solution - Follow recommended **powder water ratio**
